# Manhole Inspection Summary

Manhole # S43I\_\_023MH

Insp Date: **5/1/08 7:23 AM**

**Location** Address: **1421 Eastern Av**

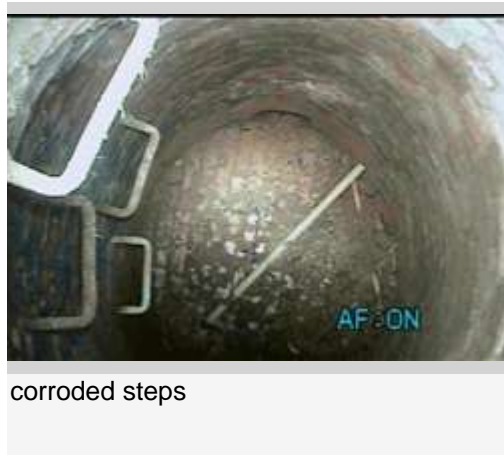
Defect 3

Count: **4** Missing: **0** ☒ **Corroded**

channel debris

corroded steps

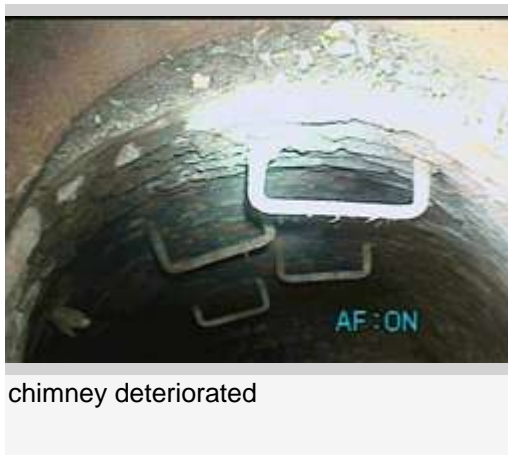
Defect 2

Condition: ☐ Sound ☐ Cracked ☐ Root Intrusion ☐ Loose Brick ☒ **Deteriorated**

chimney deteriorated

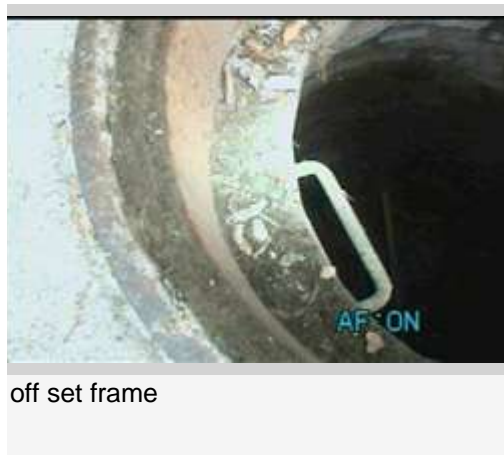
Defect 1

Offset: **4** (in.)

off set frame
